Fissure structure analysis to unravel groundwater inflow problem in gold mining site of Pongkor area, West Java, Indonesia

1
Fissure structure analysis to unravel groundwater inflow problem in gold mining site of Pongkor area, West Java, Indonesia

Sari Bahagiarti Kusumayudha*, Puji Pratiknyo, Purwanto and Herry Riswandi

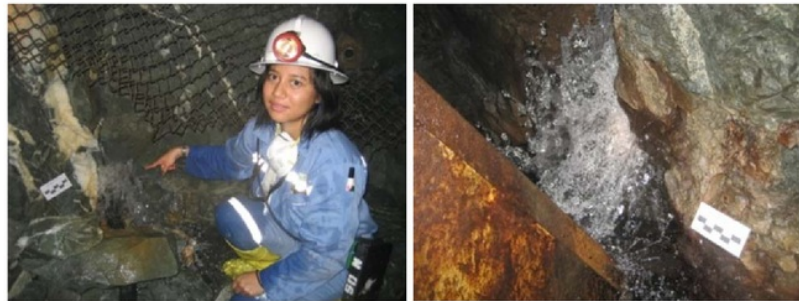
Figure 9 Groundwater inflows through fractures to the tunnel (see online version for colours)

As indicated by Chiu and Chia (2012), there can be an impact of groundwater discharge to such a tunnel penetrated a water source. In the study area, there is groundwater inflow to the tunnel through fissures system (Figure 9). Results of flow rate measurements on river Cikaniki and its tributaries around Vein Ciurug demonstrate two trends, i.e., in the north part the maximum flow rate is 7.70 m³/s, and in the south part the maximum flow rate is 32.88 m³/s. It reflects such a significant decrease of the flow rate of river Cikaniki system before crosscutting the fault (38–48 m³/s) and after (20–27 m³/s). This condition strengthens the assumption that there is such a leakage of river Cikaniki into the tunnel through fissure system, causing massive groundwater inflow to the ramp down at the elevation under +500 m asl, flooding the tunnel.

Special wall grouting by pre-excavation grouting (PEG) method, using *microfine cement* (MC) supplemented with *colloidal silica* (CS) (Garshol et al., 2013) is need to be done on the fault zone in the tunnel of where the water inflow, and at the location of where river Cikaniki is crosscut by the fault. On the other hand, in order to drain the water that already flooding the tunnel, a draining system can be operated.

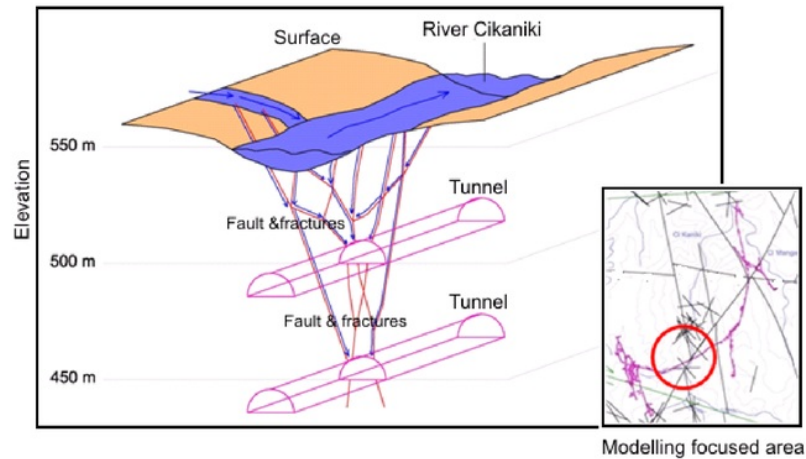
Figure 10 Conceptual model of hydrogeological leakage from river Cikaniki to the tunnel (see online version for colours)

Referring to Petchsingto and Karpyn (2010), Saha (2013), and Hernandez et al. (2016), based on hydrogeologic and surface flow data analysis, the hydrogeological conceptual model of area around the meeting point of river Cikaniki and Cikaniki fault system can be developed, and is shown in Figure 10.

There is a leakage of river Cikaniki stream into the fracture scheme that cuts the tunnel, causing flooding in the tunnel. This problem disrupts mining activities at ramps with elevation lower than +500 metres above sea level. Recommendation to solve the problem is tunnel wall grouting on the site of groundwater inflow by high pressure grouting (PEG) method, grouting at the fault zone on the bottom of river Cikaniki stream, and draining system in the tunnel that is subjected to groundwater flooding.
