Correlation between geological structures and kinematic analysis to identify the vulnerability zone of slope failures on Samigaluh and Borobudur District

Cite as: AIP Conference Proceedings **2363**, 040013 (2021); <https://doi.org/10.1063/5.0061488>
Published Online: 23 November 2021

Istifari Husna Rekinagara^{1,a)}, Sari Bahagiarti Kusumayudha²⁾, Jatmika Setiawan²⁾,
Oktarian W. Lusantono³⁾, Barlian Dwinagara³⁾

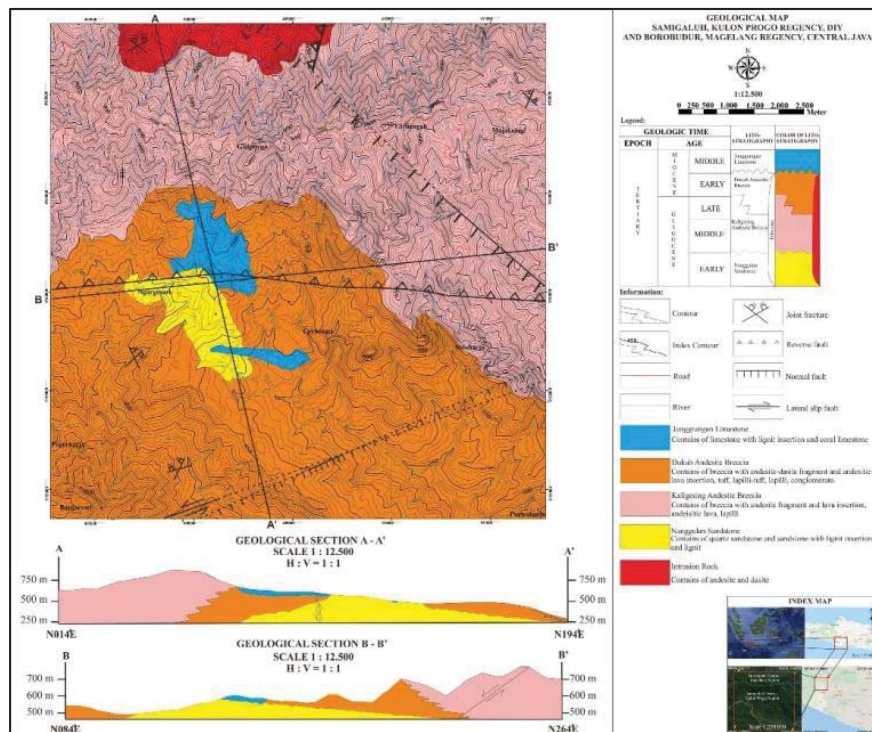
FIGURE 4. Geological Map

Four structures in the shape of a shear joint have been found based on field data (**FIGURE 4**). Three fractures with the main stress direction (σ_1) $N245^\circ E$, $N187^\circ E$, and $N149^\circ E$, respectively, were found in Dukuh Andesite Breccia. In the Andesite Intrusion Rocks, a fracture in the direction of σ_1 $N096^\circ E$ was found. According to Rickard, 1972, these studies were intended to assess the classification of the fault [5].

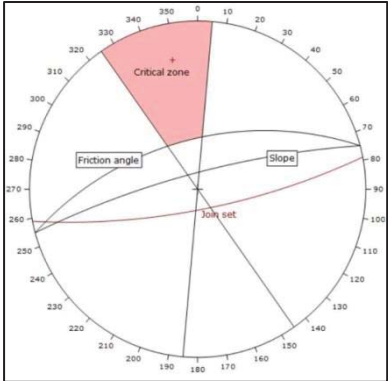
Rock Type	Lapilli pyroclastic	
	Failure Type	Toppling (100%)	
	Failure Direction	N345°E	
2	Location	LP 4

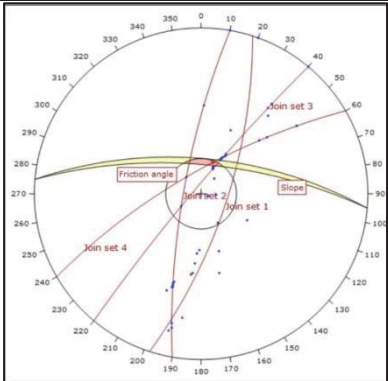
Rock Type	Andesite	
	Failure Type	Wedge (4.44%)	
	Failure Direction	N050°E	
3	Location	LP 5

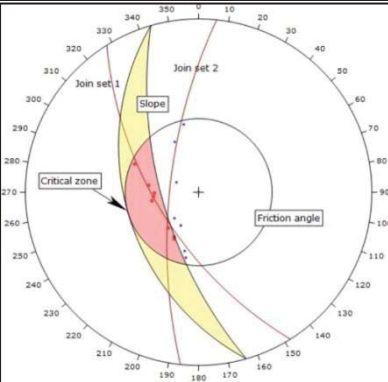
Rock Type	Andesite	
	Failure Type	Wedge (53.55%)	
	Failure Direction	N235°E

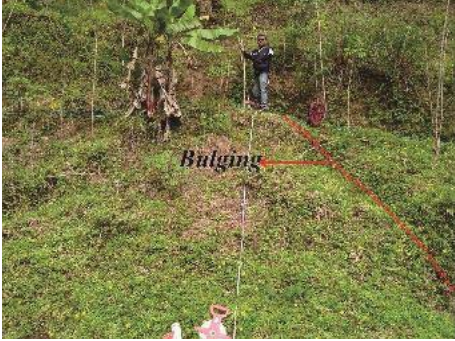
No.	Slope Conditions		Slope measurement picture
1	Location	LP 1 X: 406738; Y: 9153360; Z: 550 Ngargosari Village area, Samigaluh District, Kulon Progo Regency, DIY

<p>Azimuth of N290°E</p>
	Slope properties	Slope length: 12 m Slope height: 10 m Slope angle: 56°	
	Slope condition	<ul style="list-style-type: none"> • Bulging • It lies on the Northwest from the main road and settlement 	
2	Location	LP 4 X: 407777; Y: 9153802; Z: 625 Ngargosari Village area, Samigaluh District, Kulon Progo Regency, DIY

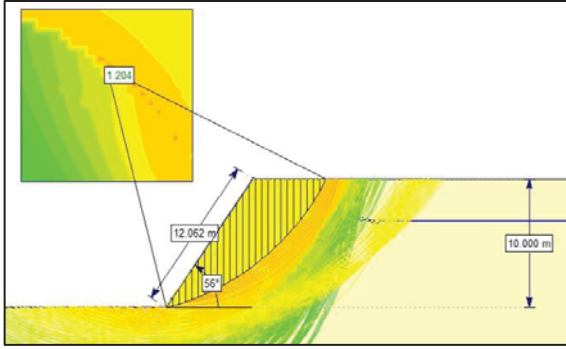
Location	Geological and slope condition	Soil properties	Type of failure potential	Information	Recommendation
Soil Slope 1 Ngargosari Village, Samigaluh Regency (FIGURE 5)	<ul style="list-style-type: none"> • With a steep slope, bulging symptoms occur. • The slope classification is also comparatively steep. 	H: 10 m L: 12 m Slope: 56° c: 0,29 kg/cm ² Φ: 22° γ: 2,18 gr/cm ³	<i>Debris fall</i> -FK _{saturated} : 0,947 (unsafe) -FK _{half-saturated} : 1,204 (critical) -FK _{dry} : 1,355 (safe)	It is located in the Northwest from inter-village roads and settlements.	- Reducing the angle of the slope (tiered slope). - Monitoring the surface water (drainage) so that the water content in the soil forms a proper slope. - Reduce the slope's pressure by not building above it.
Soil Slope 4 Ngargosari Village, Samigaluh Regency (FIGURE 6)	It used to happen in his region with landslide disaster. This slope classification is also comparatively steep.	H: 21,83 m L: 24,5 m Slope: 63° c: 0,12 kg/cm ² Φ: 68,43° γ: 1,68 gr/cm ³	<i>Earth slides</i> -FK _{saturated} : 0,03 (unsafe) -FK _{half-saturated} : 0,641 (critical) -FK _{dry} : 2,12 (safe)	It is located near inter-village roads and settlements.

FIGURE 5. The FoS on soil slope with half-saturated condition: **1.204 (critical)**

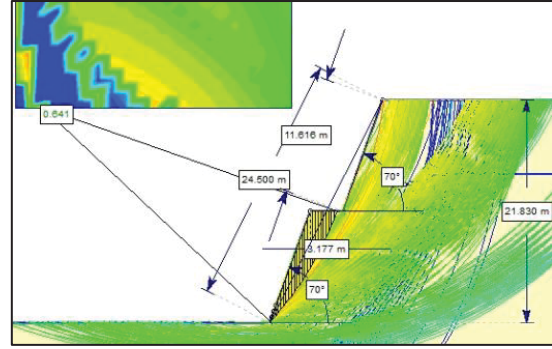
FIGURE 6. The FoS on soil slope with a half-saturated condition: **0.641 (critical)**

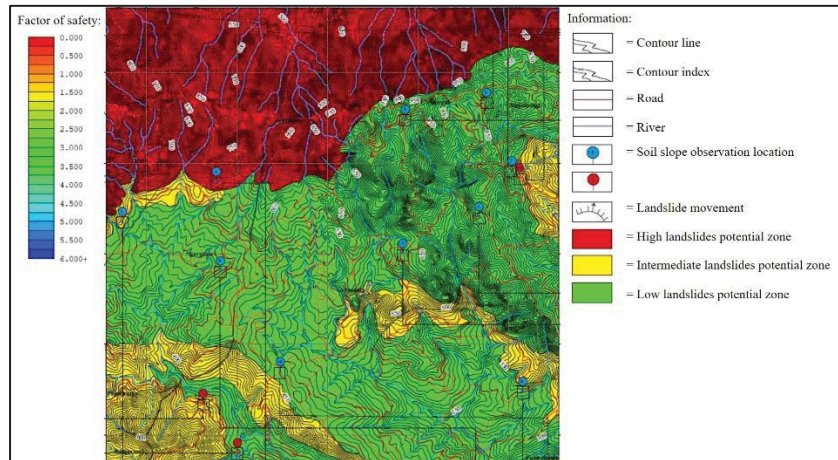
FIGURE 7. Vulnerability Zone Map

The vulnerability zone of slope failure in research area divided into three zones; they are high (red), intermediate (yellow), and low (green) landslide potential zone. This classification was based on the distribution of soil and rock slope that have been identified with both kinematic and slope stability analysis. The result stated that high landslide potential zone located on the Northern of research area with $FoS < 1.07$; intermediate landslide potential zone located in the outer zone of the research area with $1.25 < FoS < 1.07$; and low landslide potential zone located on the middle of research area with $FoS > 1.07$ (**FIGURE 7**).
