Correlation Between Geological Structures and Kinematic Analysis to Identify the Vulnerability Zone of Slope Failures on Samigaluh and Borobudur District

Istifari Husna Rekinagara^{1a)}, Sari Bahagiarti Kusumayudha^{2b)}, Jatmika Setiawan^{2c)}, Oktarian W. Lusantono^{3d)}, Barlian Dwinagara^{3d)}

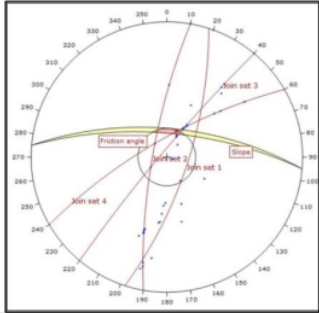
No.	Slope condition		Analysis of Markland Method
1	Location	LP 2	
	Rock Type	Lapilli pyroclastic	
	Failure Type	Toppling (100%)	
	Failure Direction	N345°E	
2	Location	LP 4	
	Rock Type	Andesite	
	Failure Type	Wedge (4.44%)

Failure Direction	N050°E

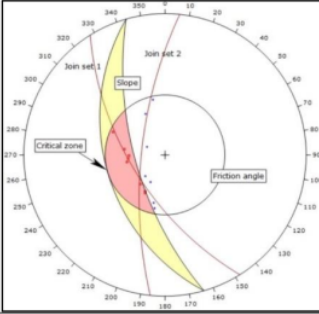
3	Location	LP 5

Rock Type	Andesite		
	Failure Type	Wedge (53.55%)		
	Failure Direction	N235°E		
4	Location	LP 6

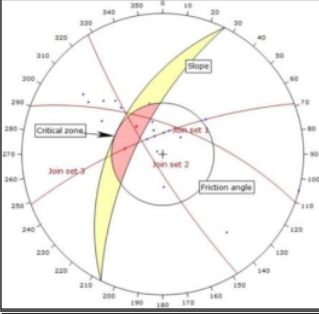
Rock Type	Andesite		
	Failure Type	Wedge (9.52%)		
	Failure Direction	N295°E		
5	Location	LP 8

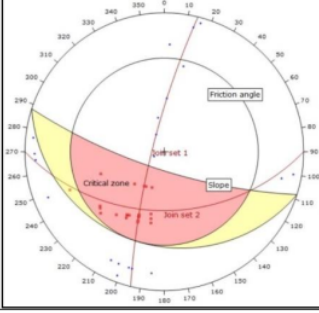
Rock Type	Weathered andesite		
	Failure Type	Wedge (55.56%)		
	Failure Direction	N205°E		
6	Location	LP 9		
	Rock Type	Weathered andesite		
	Failure Type	Wedge (77.78%)

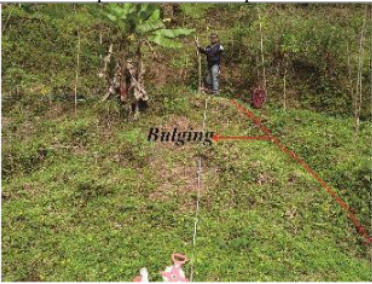
No.	Slope Conditions	Slope measurement picture
1	<p>Location LP 1 X: 406738; Y: 9153360; Z: 550 Ngargosari Village area, Samigaluh District, Kulon Progo Regency, DIY</p> <p>Slope properties Slope length: 12 m Slope height: 10 m Slope angle: 56⁰</p> <p>Slope condition</p> <ul style="list-style-type: none"> • Bulging • It lies on the Northwest from the main road and settlement

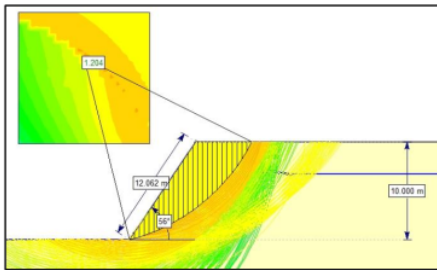
There are seven slopes with failure slope potential based on the result of kinematics analysis on rock slopes with Markland Method. Slidign and toppling wedges are become the possible forms of slope failure in the study area (TABLE-1). Besides, there were two areas have soil sliding potential (TABLE-2 and TABLE-3). These 2 of soil slope have critical and unsafe FoS; they were 1.204 (FIGURE-5) and 0.641 (FIGURE-6), respectively.

Location	Geological and slope condition	Soil properties	Type of failure potential	Information	Recommendation
Soil Slope 1 Ngargosari Village, Samigaluh Regency (FIGURE-5)	<ul style="list-style-type: none"> •With a steep slope, bulging symptoms occur. •The slope classification is also comparatively steep. 	H: 10 m L: 12 m Slope: 56° c: 0.29 kg/cm ² Φ : 22° γ : 2,18 gr/cm ³	<i>Debris fall</i> -FK _{saturated} : 0,947 (unsafe) -FK _{half-saturated} : 1,204 (critical) -FK _{dry} : 1,355 (safe)	It is located in the Northwest from inter-village roads and settlements.	-Reducing the angle of the slope (tiered slope). -Monitoring the surface water (drainage) so that the water content in the soil forms a proper slope. -Reduce the slope's pressure by not building above it.
Soil Slope 4 Ngargosari Village, Samigaluh Regency (FIGURE-6)	It used to happen in this region with landslide disaster. This slope classification is also comparatively steep.	H: 21,83 m L: 24,5 m Slope: 63° c: 0,12 kg/cm ² Φ : $68,43^{\circ}$ γ : 1,68 gr/cm ³	<i>Earth slides</i> -FK _{saturated} : 0,03 (unsafe) -FK _{half-saturated} : 0,641 (critical) -FK _{dry} : 2,12 (safe)	It is located near inter-village roads and settlements.	-Reduce the slope's pressure by not building above it.

FIGURE 5. The FoS on soil slope with half-saturated condition: **1.204 (critical)**

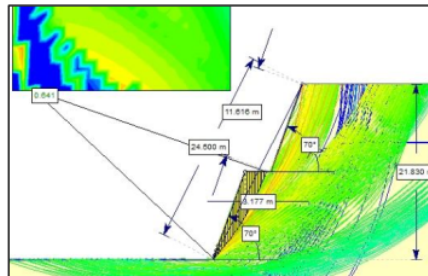
FIGURE 6. The FoS on soil slope with a half-saturated condition: **0.641 (critical)**

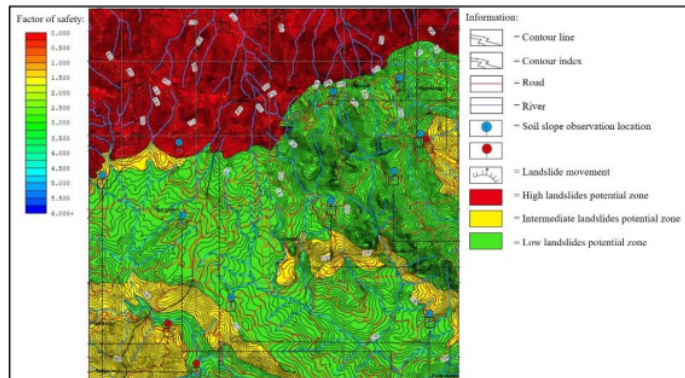
FIGURE 7. Vulnerability Zone Map

The vulnerability zone of slope failure in research area divided into three zones; they are high (red), intermediate (yellow), and low (green) landslide potential zone. This classification was based on the distribution of soil and rock slope that have been identified with both kinematic and slope stability analysis. The result stated that high landslide potential zone located on the Northern of research area with $FoS < 1.07$; intermediate landslide potential zone located in the outer zone of the research area with $1.07 < FoS < 1.25$; and low landslide potential zone located on the middle of research area with $FoS > 1.25$ (FIGURE-7).
