Correlation between geological structures and kinematic analysis to identify the vulnerability zone of slope failures on Samigaluh and Borobudur District

Cite as: AIP Conference Proceedings **2363**, 040013 (2021); <https://doi.org/10.1063/5.0061488>
Published Online: 23 November 2021

Istifari Husna Rekinagara, Sari Bahagiarti Kusumayudha, Jatmika Setiawan, et al.

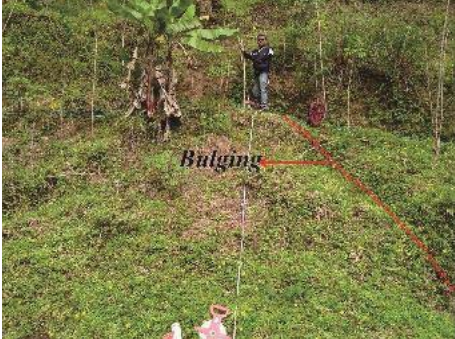
No.	Slope Conditons		Slope measurement picture
1	Location	LP 1 X: 406738; Y: 9153360; Z: 550 Ngargosari Village area, Samigaluh District, Kulon Progo Regency, DIY

<p>Azimuth of N290°E</p>
	Slope properties	Slope length: 12 m Slope height: 10 m Slope angle: 56°	
	Slope condition	<ul style="list-style-type: none"> • Bulging • It lies on the Northwest from the main road and settlement 	
2	Location	LP 4 X: 407777; Y: 9153802; Z: 625 Ngargosari Village area, Samigaluh District, Kulon Progo Regency, DIY

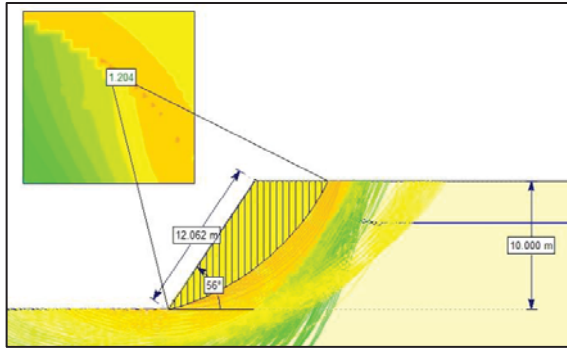
There are seven slopes with failure slope potential based on the result of kinematics analysis on rock slopes with Markland Method. Slidign and toppling wedges are become the possible forms of slope failure in the study area (**TABLE-1**). Besides, there were two areas have soil sliding potential (**TABLE-2** and **TABLE-3**). These 2 of soil slope have critical and unsafe FoS; they were 1.204 (**FIGURE 5**) and 0.641 (**FIGURE 6**), respectively.

FIGURE 5. The FoS on soil slope with half-saturated condition: **1.204 (critical)**

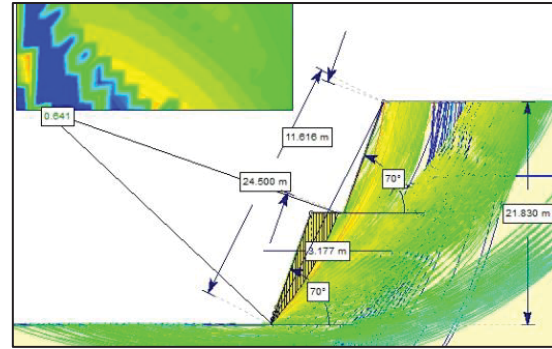
FIGURE 6. The FoS on soil slope with a half-saturated condition: **0.641 (critical)**

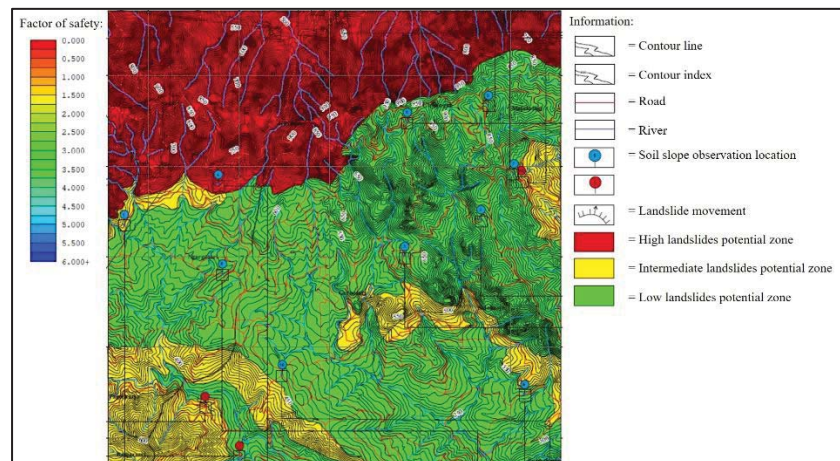
FIGURE 7. Vulnerability Zone Map

The vulnerability zone of slope failure in research area divided into three zones; they are high (red), intermediate (yellow), and low (green) landslide potential zone. This classification was based on the distribution of soil and rock slope that have been identified with both kinematic and slope stability analysis. The result stated that high landslide potential zone located on the Northern of research area with $FoS < 1.07$; intermediate landslide potential zone located in the outer zone of the research area with $1.25 < FoS < 1.07$; and low landslide potential zone located on the middle of research area with $FoS > 1.07$ (**FIGURE 7**).
