1 Geology and Slope Stability Analysis using Markland Method on Road Segment of Piyungan – Patuk, Sleman and Gunungkidul Regencies, Yogyakarta Special Region, Indonesia

1
B. N. Kresna Citrabhuwana*, Sari Bahagiarti Kusumayudha, Purwanto

Universitas Pembangunan Nasional “Veteran” Yogyakarta.

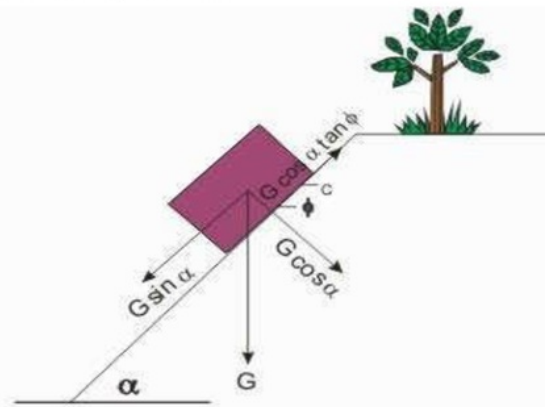
G = weight force
 α = slope inclination
 Φ = friction angle of rock mass and the sliding plane
 c = cohesion force

Fig. 2 Stress distribution on a slope (Hoek & Bray, 1981; Franklin & Dussault, 1989, Goodman, 1989, Price, 2009).

On such a slope, there is force or stress system that when the equilibrium is disturbed, it will create mass movement. According to rock mechanics principle, stress distribution of a slope is displayed in Figure 2.

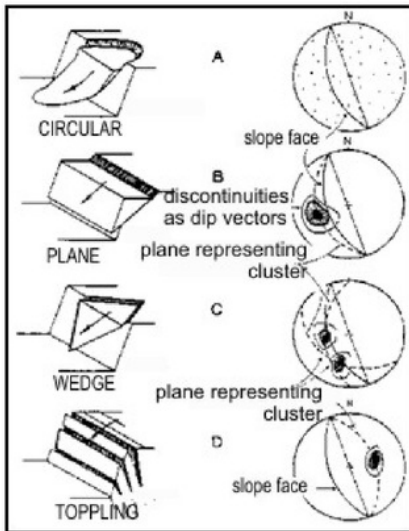
Fig. 3 Stereographic projection of slope failure model by Markland (Hoek & Bray, 1981).

detail by Hoek & Bray (1981). Markland method classifies types of rock mass movements in stereographic projections as shown in Figure 3.

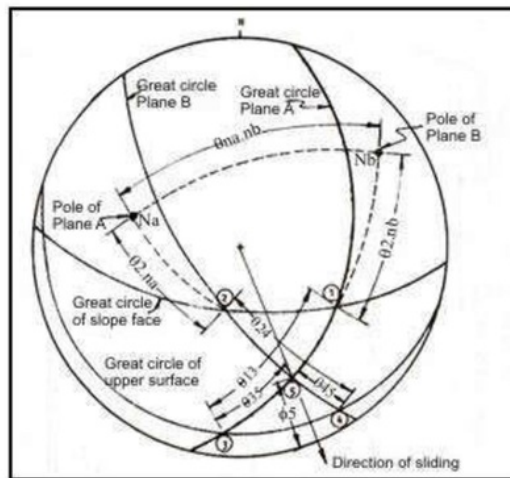
Fig. 4 Method to determining factor of safety for wedge failure (Hoek and Bray, 1981).

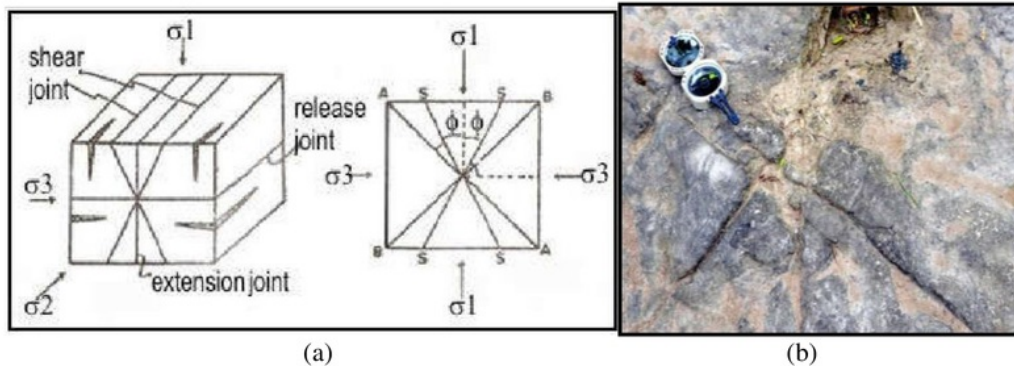
Fig. 6 (a) Joint pattern and stresses working on such a rock mass (Billings (1979)). (b) Joint pattern on sandstone of the study area.

Joints and fissures are geological structure caused by stresses, either compressional or tensional. Based on their origin and shape, fissure structures in the study area are classified into shear joint, which refer to Billing (1979) can be used to determine the main direction of the major stresses (σ_1 , σ_2 , dan σ_3) (Fig 6).

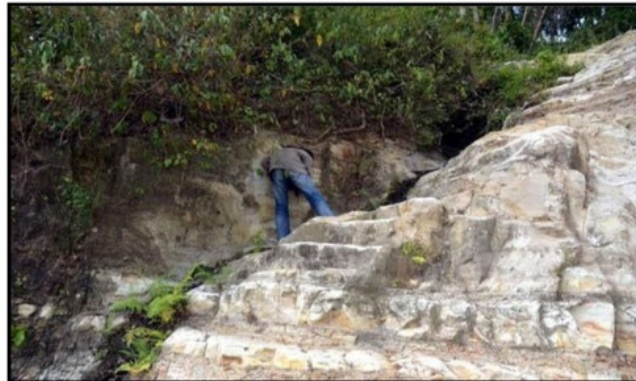
Fig. 7 Fault cross cutting tuffaceous sandstones and silts of Semilir Formation in such an edge of road segment Patuk – Piyungan.

There is a fault that the tracks are clearly recorded on such a tuffaceous sandstone outcrop on one edge of road segment of Piyungan – Patuk (Fig 7). Position of

the fault plane is N077°E/83°. In accordance with the classification of Rickard (1972) vide Billings (1979), using measurement data in the form of rake = 9°, Plunge = 7°, and bearing = N256E°, the fault type belongs to left slip lateral fault.

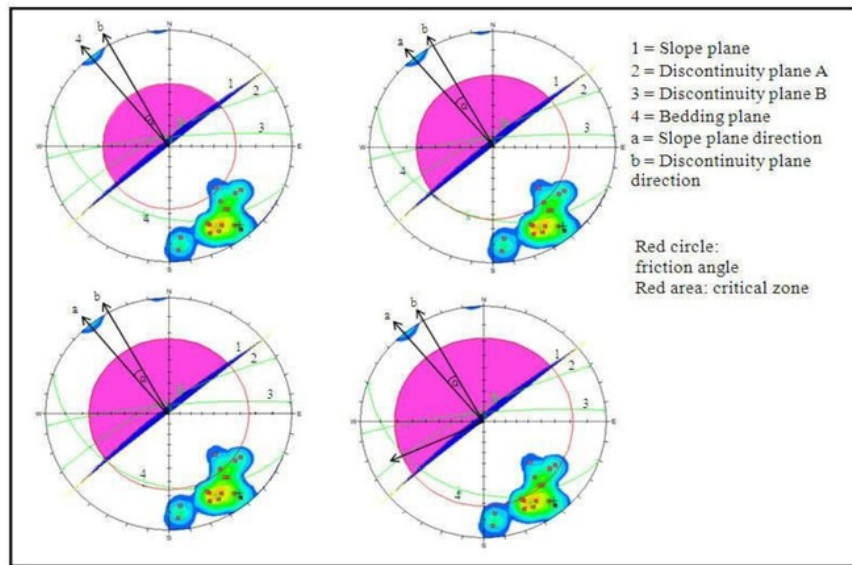
Fig. 8 Slope stereo plot analysis of LP 2.

Slope located at LP 2 is occupied by well bedded sandstone and tuff of Semilir Formation. The location is on the coordinate of x: 442580 and y: 9133512 (UTM). Strike and dip of bedding plane is N120°E/31°, while the slope face is N230°E/83°. Fig. 8 shows configuration of the slope with various values of friction angle.

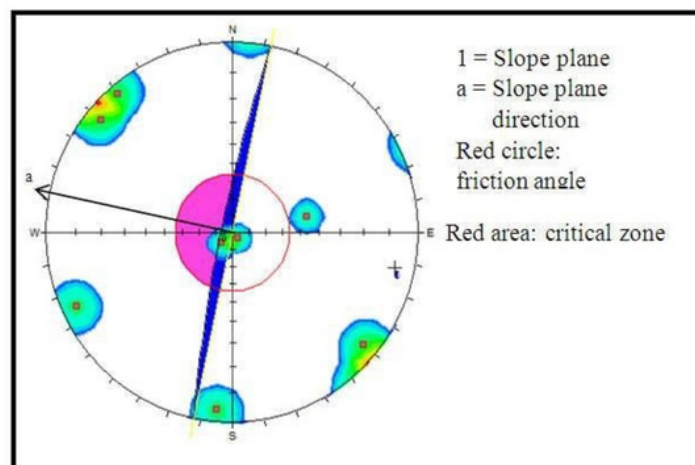
Fig. 9 Slope stereo plot analysis of LP 3.

Slope at LP 3 is occupied by volcanic breccias of Nglanggran Formation. There is no bedding identified, but joints of various strikes and dips. LP 3 is situated on the coordinate of x: 443003 and y: 9133140 (UTM). Slope plane position is N192°E/80°. Fig. 9 is the stereo plot of the slope condition.

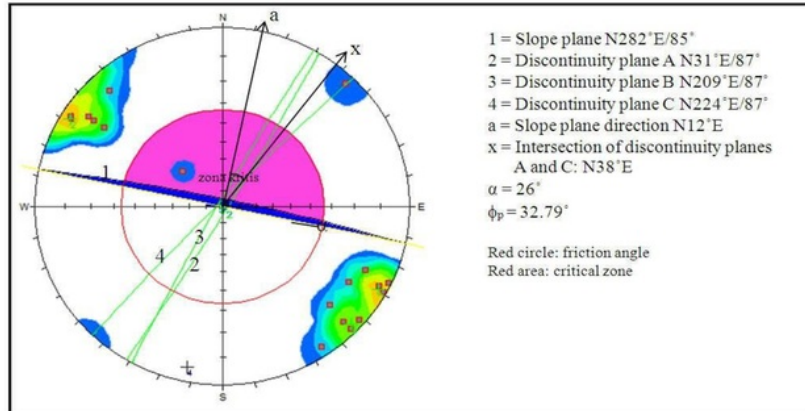
Fig. 10 Slope stereo plot analysis on sandstone with peak friction angle (c_p) of LP 54.

plots with various values of friction angle of the slope are shown in the Figures 10, 11, 12, and 13.

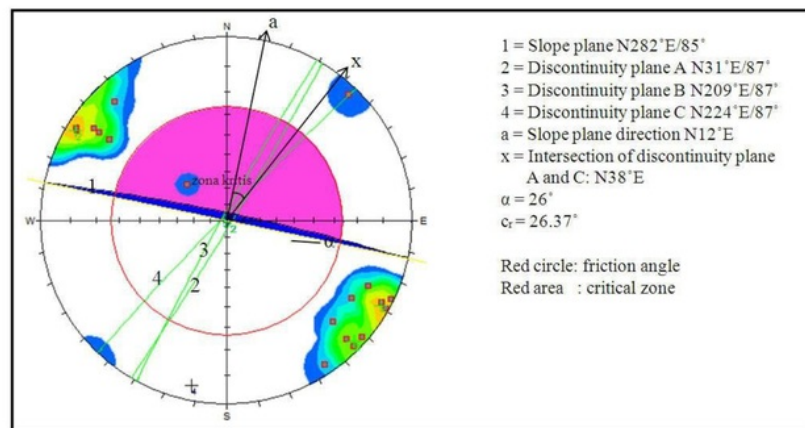
Fig. 11 Slope stereo plot analysis on sandstone with residual friction angle (c_r) of LP 54.

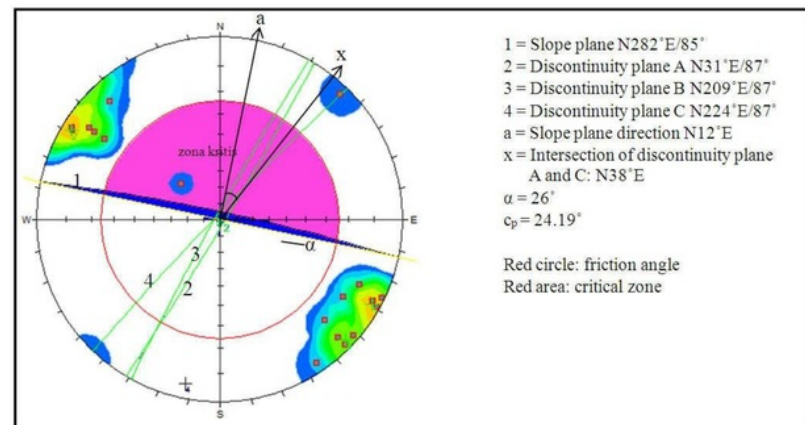
Fig. 12 Slope stereo plot analysis on tuff with peak friction angle (c_p) of LP 54.

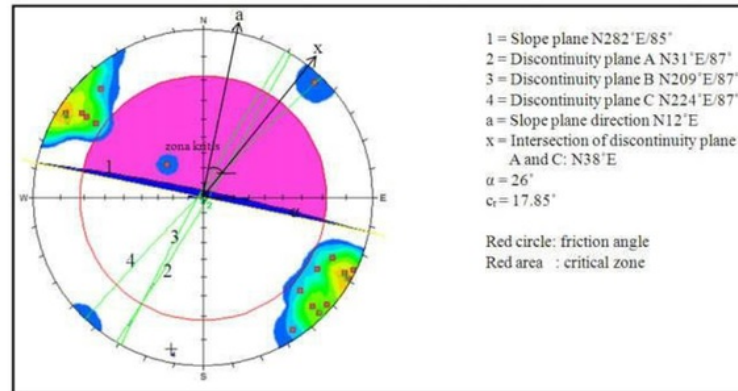
Fig. 13 Slope stereo plot analysis on tuff with residual friction angle (c_r) of LP 54.

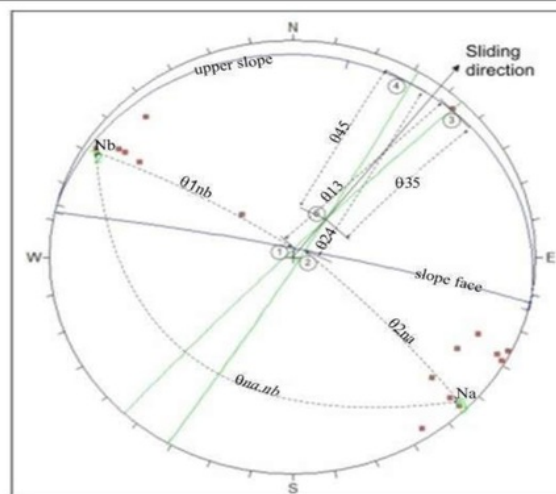
Fig. 14 Stereo plot to determine the safety factor of wedge failure at LP 54.

Based on the results of Markland analysis, the slope of LP 54 is potential for wedge failure through the plane of intersection involving two discontinuities of plane A and plane C. Table 2 and Figure 14 display components used to derive the safety factor of wedge failure in LP 54.

Result of computation using both peak and residual values of friction angles and cohesion force shows that the safety factor of slope at LP 54 is less than 1. It indicates that the slope is unstable. Based on data obtained from various ways of analysis including from stereo net plotting especially for rock, dips software for soil, safety factor analysis, and direct field observation, the stability of the slope in the study area is concluded in Table 5.
