Geohazard assessment in Borobudur Temple area, Central Java, Indonesia

H Murwanto¹, Sutarto¹, A Purwoarminta² and A Sulaksono¹

Abstract. Borobudur attracted some researchers to study not only about its temple and culture but also the environment. Borobudur environment is very interesting because Borobudur located in the hill and surrounded by swamp. However, behind the beautiful place, Borobudur is vulnerable from natural hazard. Earthquake and volcanic eruption are the main disaster that can destruct the temple. Geological evidence could help the government to protect the temple or to develop the tourism. The aims of research are to assess and analyze natural hazard potential base on geological condition in Borobudur temple area. The research was conduct from 2008 to 2013 with compile primary and secondary data. The data were collected from secondary data validated that which were collected in the field. Several indicators of geohazard i.e. fault, volcanic materials, and landslide sediment were shown the vulnerability of research area. Base on this condition government should consider geological factors to develop and protect Borobudur temple and surrounding areas.

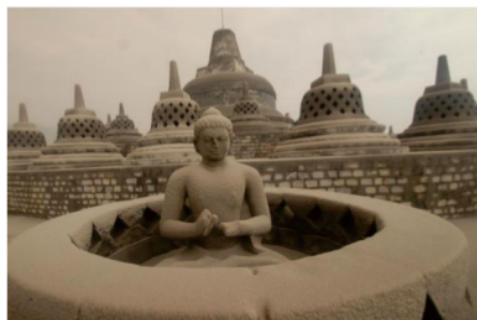
Figure 1. Borobudur temple covered by volcanic ash in Merapi eruption 2010 (Source: Borobudur Conservation Center)

Even though Borobudur was located near many volcanoes but not all of them threat the temple. Merapi is the most active and often threat Borobudur for instance eruption in 2010 that Borobudur covered by volcanic ash (Figure 1). Due to chemical content, volcanic ash can destroy the temple materials and also disturb drainage system.

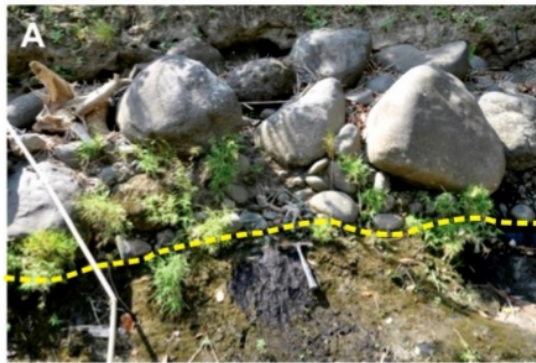
Figure 2. Lake sediment covered by volcanic material in Progo river East part of Borobudur area

The previous Merapi eruption until now is always triggered lahars. The lahars flow occurs caused by loose material around the volcanic peak, sliding down affected by gravity and rain. Lahar flow has high velocity so can destroy the buildings in surround od the river. Moreover, the volcanic materials will accumulate in the rivers (Figure 2). Black clay deposit covered by volcanic materials from Merapi volcano eruption that flowed through ancient Pabelan River and come down into Lake Borobudur. Some rivers come down in Borobudur area from the upstream of Merapi volcano, including Mangu River, Pabelan River, Kunjang River, Keji River, Putih River, Lamat River and Gung River. These rivers serve as a stream of material from Merapi eruption. Volcanic materials in Borobudur area are found in the river valleys, above the black clay sediments.

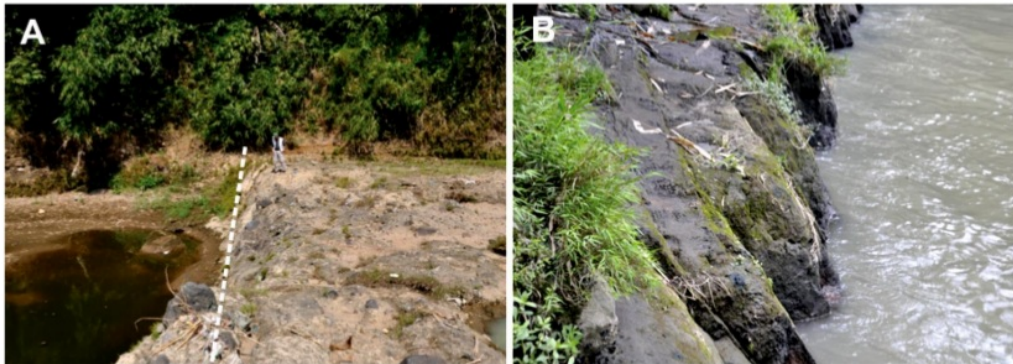
Figure 3: A. The fault outcrop in Progo river that cut by volcanic breccia and forming a valley. B. Black clay or swamp sediment was cutted by fractures.

3.2.2.1 Progo Fault. Progo is a river that located around 3 kilometers in the East of Borobudur temple. In many area show the river meandering pattern that controlled by tectonic. This fault cut the volcanic breccia with N 150° E (Figure 3-A). If a straight line drawn, it will be shown the fault cut Menoreh hills. While at east of Pawon temple, the fractures were founded cut swamp sediment (black clay) (Figure 3-B). This indicates that fault is active due to cut black clay which is a Quaternary sediment. These faults make the old swamp sediment located in the same elevation with young sediment. The sediment uplifting is a prove of tectonic activity in Borobudur Plain area.
