# LANDSLIDES AND SLOPE STABILITY

# KINEMATICS ANALYSIS AND THE ROLE OF GEOLOGICAL STRUCTURES ON SLOPE FAILURES OF MENOREH HILLS, CASE STUDY: SAMIGALUH DISTRICT, KULON PROGO REGENCY AND, BOROBUDUR DISTRICT, MAGELANG REGENCY, INDONESIA

**ABSTRACT:** Menoreh Hills in the Kulonprogo Regency of Yogyakarta Special Territory, Magelang Regency and Purworejo Regency in Central Java belongs to landslide subscriptions area in almost every rainy season. The most recent landslides occur during late November 2018 to early January 2019. Problem of mass movements in the Menoreh Hills is a manifestation of geological conditions, including geomorphology, lithology, and especially geological structures. The lithology composing the study area is dominated by a group of volcanic rocks consisting of breccia and lava from the Kaligesing Formation and Dukuh Formation. The physical condition of these rocks is generally weathered to form soil with a thickness reaching 5 m. The geological structures exist in the study area are joints and faults caused by the main stress relative to the North-South direction. Faults in the study area can be classified into right lateral slip fault, left lateral slip fault,

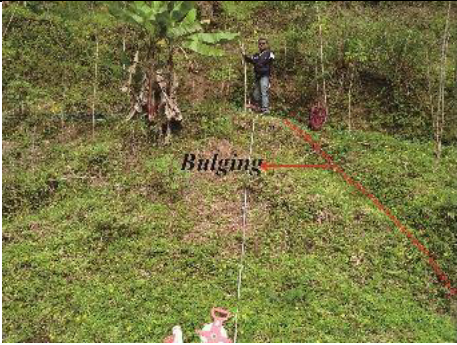
| No. | Slope Condition | | Slope measurement picture |
|---|---|---|---|
| 1 | Location | LP 1<br>X: 406738; Y: 9153360;<br>Z: 550<br>Ngargosari Village area,<br>Samigaluh District,<br>Kulon Progo Regency,<br>DIY | <p>Azimuth of N290°E</p> |
| | Slope properties | Slope length: 12 m<br>Slope height: 10 m<br>Slope angle: 56° | |
| | Slope condition | <ul style="list-style-type: none"> <li>Bulging</li> <li>It lies on the Northwest from the</li> </ul> | |

| Location | Geological and slope condition | Soil properties | Type of failure potential | Information | Recommendation |
|---|---|---|---|---|---|
| Soil Slope 1<br>Ngargosari Village,<br>Samigaluh Regency | <ul style="list-style-type: none"> <li>There is bulging symptoms with a fairly steep slope.</li> <li>Also the slope classification is relatively steep.</li> </ul> | H: 10 m<br>L: 12 m<br><i>Slope</i> : 56°<br>c: 0,29 kg/cm <sup>2</sup><br>$\Phi$ : 22°<br>$\gamma$ : 2,18 gr/cm <sup>3</sup> | <i>Debris fall</i><br>-FK <sub>saturated</sub> : 0,947 (unsafe)<br>-FK <sub>half-saturated</sub> : 1,204 (critical)<br>-FK <sub>dry</sub> : 1,355 (safe) | Located in the Northwest from inter-village roads and settlements. | - Reducing the slope angle (tiered slope).<br>- Control the surface water (drainage), so that the water content in the soil makin up the slope is sufficient. |
