The Land Degradation Based on Landslide Parameters in Clapar Area, Banjarnegara Regency, Central Java

Sugeng Raharjo^{1*}, Eko Teguh Paripurno¹, Joko Hartadi¹, Oktavia Dewi Alfiani¹
Megasari Widyastuti², Muflichatul Mardziah²

ABSTRACT

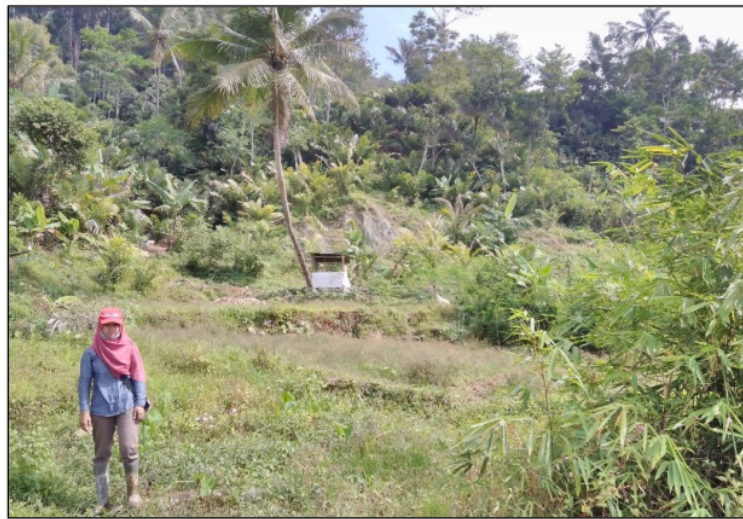
Figure 3. Landslide slope in Clapar village.

This analysis is obtained by landslide slope geometry measurement and taking soil sample from top and bottom of landslide slope in research area. Furthermore, this soil sample analyzed with direct shear test to obtaining the angel of shear strength and cohesion of soil. Those data then modeled to get the safety factor value and classification of landslide slope condition (Bowles, 1991). Angle of shear strength from direct shear test soil sample in Clapar slope is 27° with safety factor value is 1.045 included in the critical class.

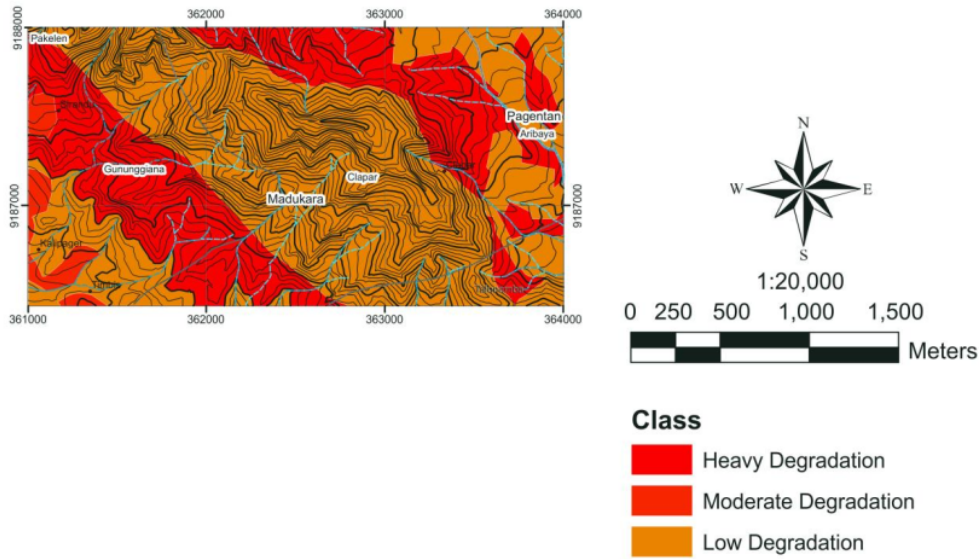
Figure 9. Classification land degradation in Clapar Area

In order to assess the magnitude of land degradation in different zone and vegetation types, a criterion was set based on field observation along transect traversing. In this case land degradation divided in 3 types that it no visible evidence of land degradation, slight land degradation and severe land degradation. Based on field observation along traverse, land degradation in Clapar Area varied with vegetation. Severe land degradation was in salaka and shrub vegetation. Slight land degradation was in pine tree and it was no visible land degradation in cocoa tree and paddy field.

The other factor of severe land degradation in this area is probably due to the high steepness of slope (30 – 70%) and the dominant lithology consist with clay. In area with high steepness of slope, clay lithology and low safety factor value, salak and shrub that have fibrous root can make soil loosen and creating chance for water and wind caused degradation to take place. Those data above can be strengthened with geodetic measurement data. The measurement point that moved took place in very steep slope with the lithology consist of clay, the vegetation consist of salak farm and shrub.
