Rock slope kinematics analysis by Markland method of the Bener District, Purworejo Regency, Central Java, Indonesia

Sari Bahagiarti Kusumayudha, Azwar Thamrin, Heru Sigit Purwanto

Department of Geological Engineering, Faculty of Mineral Technology, Universitas Pembangunan Nasional "Veteran" Yogyakarta, Yogyakarta, Indonesia

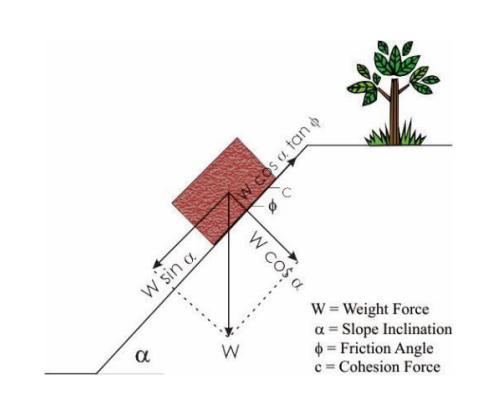
Figure 2. The distribution of stress on a slope [9]

Force is the cause of material movement. Stress is defined as the application of force to a specific area. Disturbance of the balance of force distribution in such a slope causes soil or rock mass movement [10]–[12]. Figure 2 depicts the distribution of stresses acting on a slope. The basic theory of the study states that slopes constructed of hard rock have different characteristics from slopes constructed of soil [4], [9], [10].

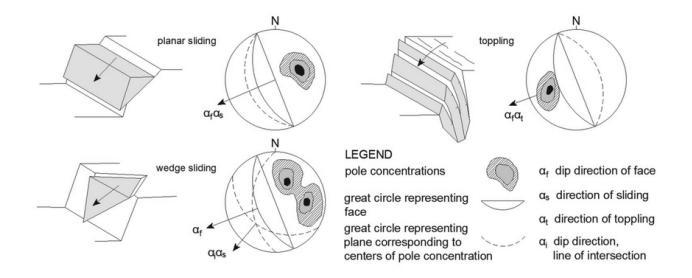
Figure 3. Stereographic projection model of rock slope failures [5]

The slope's stability in such conditions is entirely determined by rock shear strength [9]. The presence of weak planes or discontinuities, such as layering, jointing, fracturing, faulting, and foliation, or other geological structures, generally influences rock shear strength [13], [14]. An analytical method developed by Markland [4] can be used to predict potential slope failures, particularly those built with massive and fresh rock. To determine the potential slope failures, especially those built by massive and fresh rock, an analytical method by Markland [4] can be applied. The rock failure model on a slope according to Markland in Hoek & Bray [4] is outlined in Figure 3.

Types of failures on a slope comprising fresh rock can be categorized as planar slides, wedges, and topless or topplings [4]. Meanwhile, the slope stability is determined based on its safety factor. In general, the determination of the value of a safety factor is based on the (1).

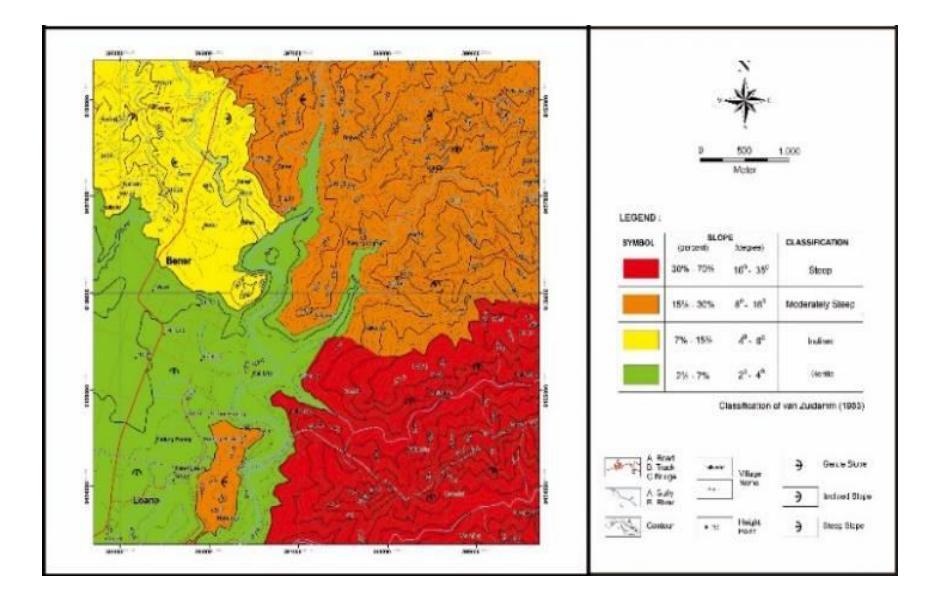
Figure 4. Slope distribution map of the Bener District and surrounding area

study area are closely related to lithology, geological structure, and weathering processes. On the other hand, the topographical slope distribution can be classified into gentle (2%-7%), inclined (7%-15%), moderately steep (15%-30%), and steep (30%-70%), as expressed in Figure 4.

The results of this study conclude that the study area's geomorphology can be classified as structural hills (S1), homoclynal valleys (S2), alluvial plains (F1), river bodies (F2), and flood plains (F3). The drainage pattern is sub-dendritic, that is controlled by the distribution of lithology and geological structures, namely joints and faults. The slope distribution shows a very wide variety, ranging from 0° (flat) to 55° (very steep).

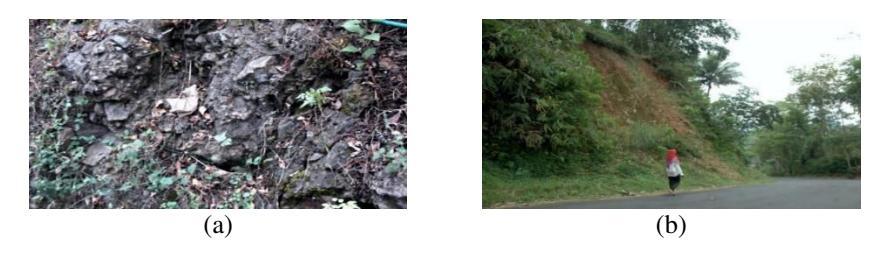
Figure 5. Volcanic breccia of the Kaligesing Formation at Telogoguwa village in condition (a) fresh and (b) weathered

Stratigraphy of the study area from the oldest to the youngest comprises Kaligesing Formation composed of volcanic product rocks, Sentolo formation, and alluvial deposits. There is an andesite intrusion that breaks the Kaligesing Formation. The Kaligesing Formation, at the bottom part predominantly consists of andesite pyroclastic breccia and andesite lava (Figure 5), Figure 5(a) shows volcanic breccia of the Kaligesing Formation in fresh condition and Figure 5(b) shows the weathered condition, in Telogoguwa Village, while the upper part is mainly occupied by andesite laharic breccia, with the insertion of volcanic sandstones. The andesite intrusion shows columnar joint and sheeting joint structures, with a position of N 285° E/80° and N 255° E/55°. On the other hand, the andesitic lava shows an auto breccia structure formed during the freezing of the lava. Such vesicular and scoria structures are also found, characterized by the presence of holes formed due to gas release during cooling. In Wadas Village, andesite lava was found with a sheeting joint structure, and in the Pajangan hill andesite lava is observed with a columnar joint structure (Figure 6), locally distributed, and there some xenoliths are found. In weathered conditions, the Kaligesing Formation forms soil reaching more than 5 m of thickness as shown in Figure 5(b).

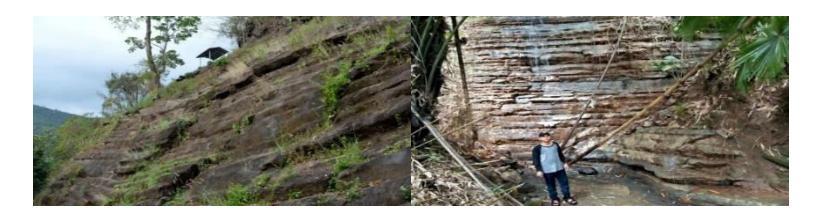
Figure 6. Andesite lava with columnar joint structure at Pajangan Hill, Sentolo Formation

Conformably overlaying the Kaligesing Formation, there is the Sentolo Formation. It consists of bedded limestone, calcareous sandstone, calcarenite, and sandy marl (Figure 6). In the calcareous sandstone, there are often found lithic fragments, allochem foraminifers, skeletal, calcite matrices, with carbonate mud cement. In general, the slope of this rock unit is trending southwest, with a position of N 155°E/5°. Alluvial deposits are produced by river stream and flood sedimentation, consisting of clay, silt, and sand-sized materials, andesite fragments, volcanic materials, and limestone-sandstone fragments of granule to boulder-sized.

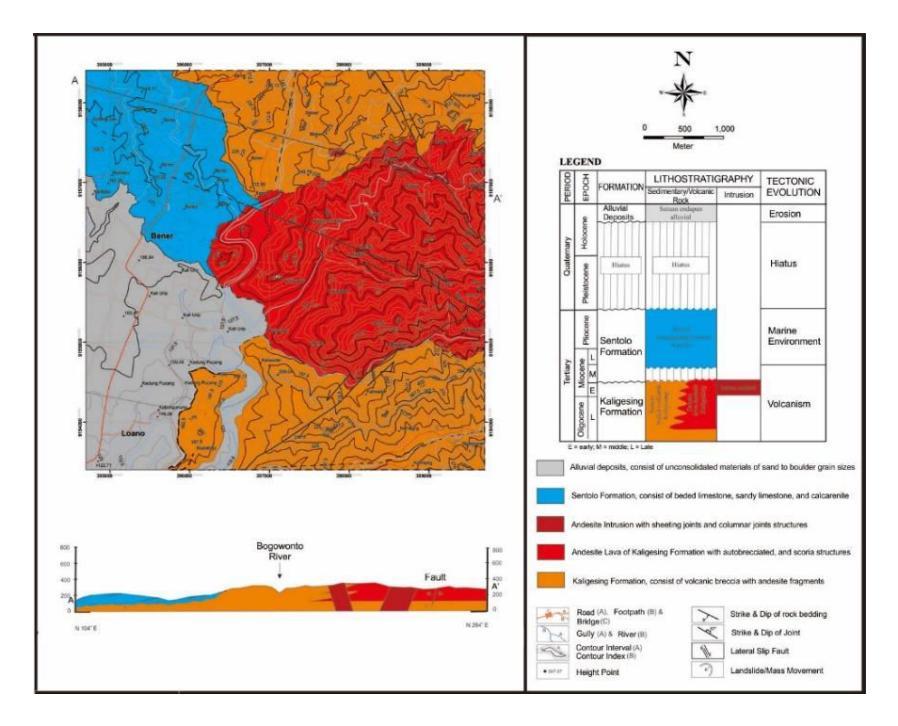
Figure 7. Geologic map of the Bener District and surrounding area [16]

The geological structures existing in the study area include joints and faults. Statistically, the joint pattern was analyzed utilizing a stereographic net diagram, the results indicated that the major stress trending to Northwest-Southeast (N 350° E/75°). There are some faults found, namely Wader Fault I, Wader Fault II, Kali Wadas Fault, and Kali Bleber Fault. Based on Rickard classification in Fossen [18], it can be stated that Kaliwader Fault I and Kaliwader Fault II belong to reverse left slip fault, Kali Wadas Fault, and Kali Bleber Fault II belong to reverse left slip fault, Kali Wadas Fault, and Kali Bleber Fault I. There are two main strike directions of faults, tending West-East and Northwest-Southeast. These faults intersect the andesite lava unit and the volcanic breccia unit of the Kaligesing Formation. A map showing the geological condition of the study area is displayed in Figure 7.

The study area's stratigraphy is made up of rock units, from the oldest to the youngest, namely, the Kaligesing Formation, which consists of andesite-lava, volcanic breccia, pyroclastic, and laharic, the Sentolo Formation, which consists primarily of bedded limestone, calcareous sandstone, and marl, and Alluvial Deposits. Andesite intrusion with sheeting and columnar joint structures exists. The main geologic structures are joints and faults. The faults are Kaliwader Faults 1 and 2, which is a reverse left slip faults with a Northeast-Southwest strike, Wadas Fault, and Bleber Fault, which are both right lateral slip faults with a Northwest-Southeast strike.

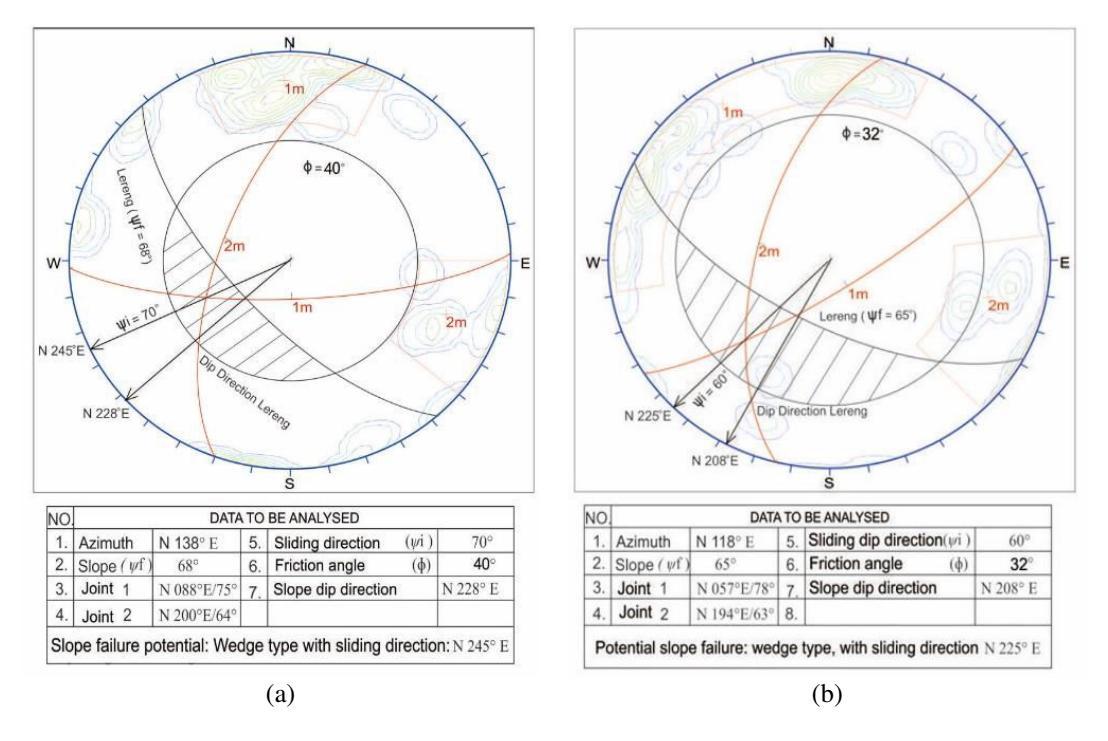
Figure 8. Kinematic analysis with potential wedge failure of (a) Kaliwader slope A and (b) Kaliwader slope B

Afterward, RMR was carried out on slope constituent rocks. From the computation of RMR, Kaliwader slopes, Argosari slope, and Wadas slope have an RMR value ranging from 45 to 48, classified as fair rock. It means that discontinuities quite exist on the rock mass. Results of the stereonet plots, kinematics analyses, as well as RMR scorings are displayed in Figures 8-10, Figure 8(a) shows kinematic analysis with potential wedge failure of Kaliwader slope A, and Figure 8(b) shows kinematic analysis with potential wedge failure of Kaliwader slope B. Figure 9(a) shows kinematic analyses of Kaliwader slopes C with wedge failure potential and Figure 9(b) shows kinematic analyses of Kaliwader slope D with no failure potential. Figure 10(a) shows a kinematic analysis of the Argosari slope with wedge failure potential and Figure 10(b) shows a kinematic analysis of the Wadas slope with planar slide failure potential. The consequences of the analyses reinforce that geologic structures, lithological properties, and geomorphography play the main actors in rock slope failures.

No.	Location	Lithology	Rock mass rating	Type of rock slope failure potential
1	Kaliwader A	Volcanic breccia	c = 21.8 Kpa, ϕ = 40°, γ = 1.805 g/cm ³ , σ = 12.41 Mpa; RMR = 45	Wedge failure, sliding direction: N 138°E
2	Kaliwader B	Weathered andesite lava	c = 15 Kpa, ϕ = 32°, γ = 2.077 g/cm ³ , σ = 6.62 Mpa; RMR = 48	Wedge failure, sliding direction: N 128°E
3	Kaliwader C	Andesite lava	c = 39 Kpa, ϕ = 51°, γ = 2.077 g/cm ³ , σ = 6.62 Mpa, RMR = 48	Unpotential to fail
4	Kaliwader D	Andesite lava	c = 39 Kpa, ϕ = 51°, γ = 2.077 g/cm ³ , σ = 6.62 Mpa, RMR = 47	Planar slide, sliding direction: N 340° E Wedge failure, sliding direction: N 002° E
5	Argosari	Weathered andesite lava	c = 39 Kpa, ϕ =35°, γ = 2.077 g/cm ³ , σ = 6.62 Mpa; RMR = 48	Wedge, sliding direction: N 225° E
6	Wadas	Andesite lava	c = 39.1 Kpa, ϕ = 47°, γ = 2.077 g/cm ³ , σ = 6.62 Mpa; RMR = 48	Planar slide, sliding direction N 254° E Wedge, sliding direction: N 271° E

According to Markland method analysis, Kaliwader slopes A, B, and Argosari slope have the potential for wedge failure, Kaliwader slope D and Wadas slope have the potential for planar slides and wedge failure types, and Kaliwader slope C is stable. The findings of this analysis can be used by the local government as one supporting data in developing a map of mass movement vulnerability zones. It will also serve as a resource for territorial development and disaster risk reduction and mitigation in communities.
